Manhole Inspection Summary

Manhole # S05YY1018MH

Insp Date: **9/21/06 10:47 AM**

Location Address: **3302 DEVONSHIRE DR**

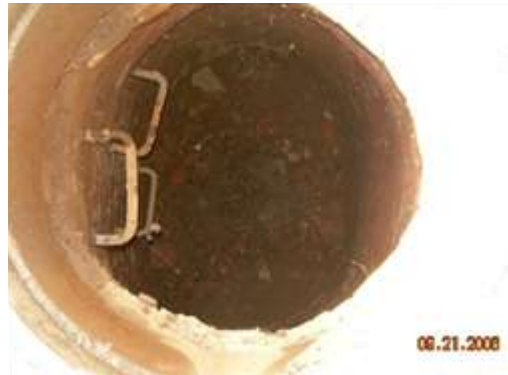
Top View

Condition: ☐ Sound ☐ Cracked ☒ **Leaks**

Condition: ☐ Sound ☐ Cracked ☐ Root Intrusion ☒ **Loose Brick** ☒ **Deteriorated**

Infiltration: ☐ None ☒ **Joint** ☐ Cracks ☒ **Mortar** ☐ Roots ☐ Wall

Infiltration: ☐ None ☐ Joint ☐ Cracks ☒ **Mortar** ☐ Roots ☒ **Wall**

Frame leaks and offset. Adjustment deterioration, loose brick and infiltration. Corbel Barrel infiltration.

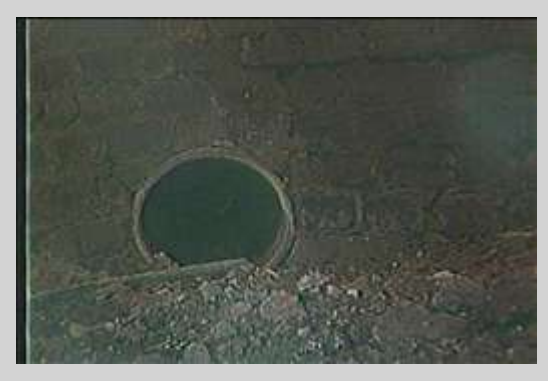
Pipe Out @ 12 O'Clock

Condition: ☐ Sound ☐ Cracked ☐ Root Intrusion ☐ Loose Brick ☒ **Deteriorated**

Infiltration: ☐ None ☐ Joint ☐ Cracks ☒ **Mortar** ☐ Roots ☒ **Wall**

Barrel deterioration and infiltration.

Infiltration: **Evidence** Pipe Seal Cond: **Cracked**
